# North Sandy Pond Long Term Shoreline Analysis and Recent High Lake Ontario Water Level Impacts

A presentation by  
Thomas F. Hart, Jr.  
to the NYS GIS Conference  
September 25, 2019

A Comprehensive Analysis of Shoreline  
Change and Inlet Dynamics on the  
Eastern Shore of Lake Ontario

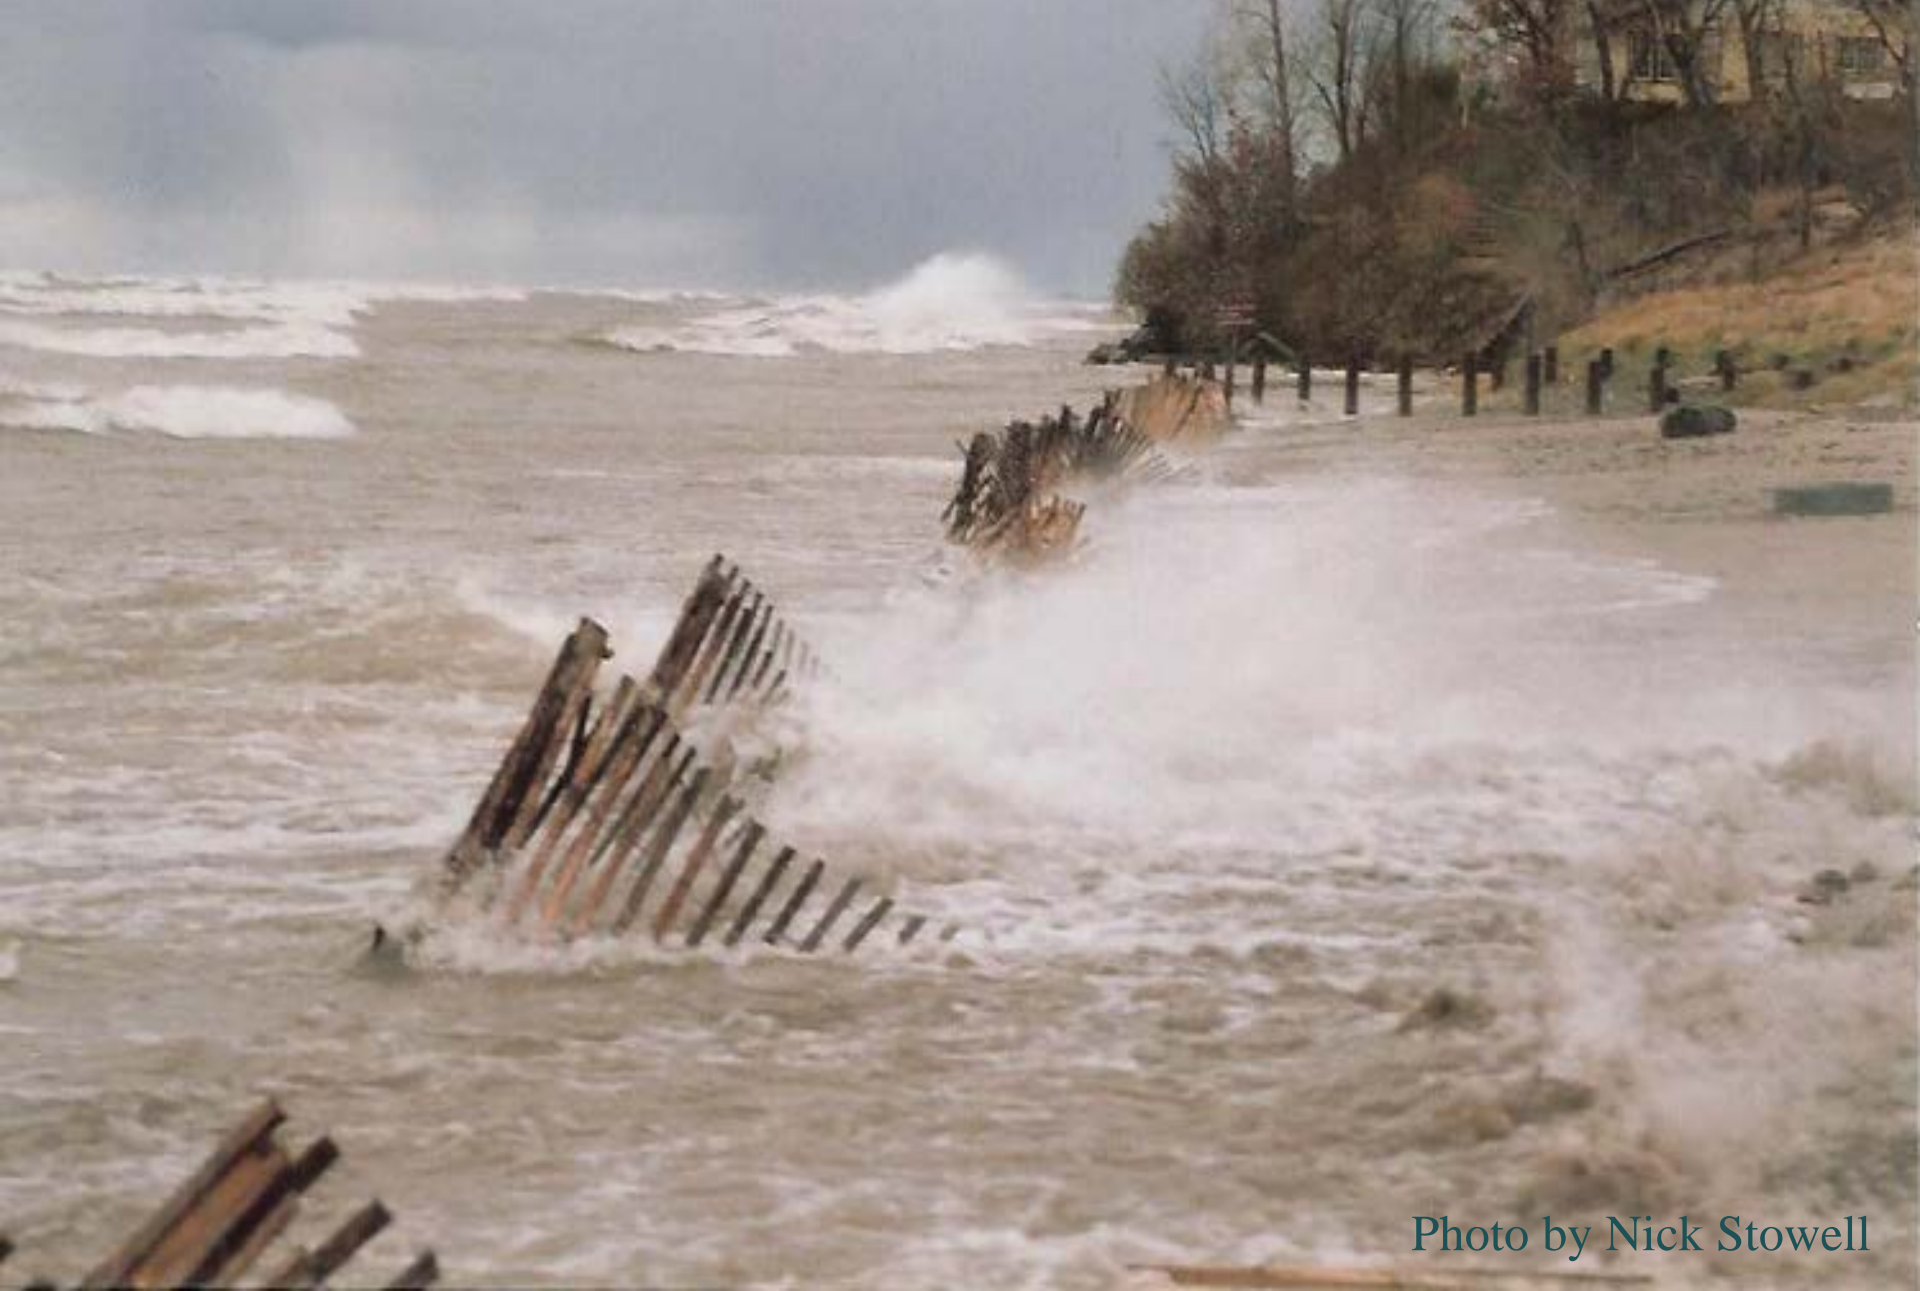
Wind-driven waves, combined with Lake water level, are the principal natural forces modifying and eroding the shoreline.

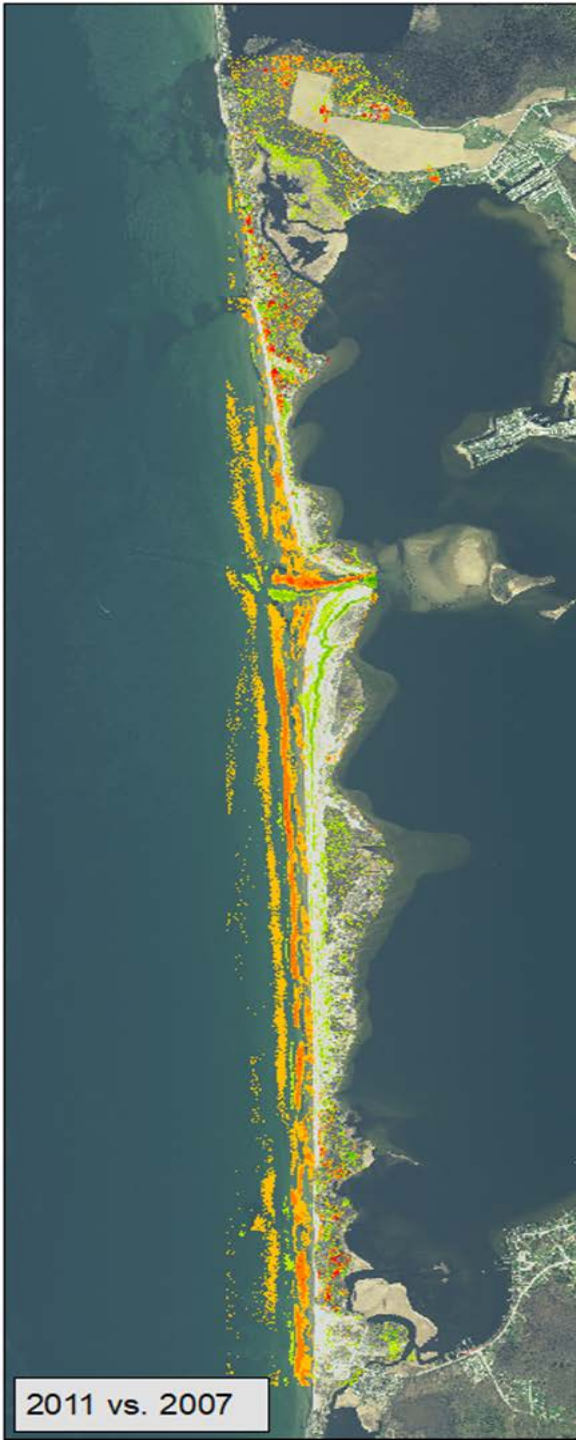
2011 vs. 2007

LiDAR-derived  
Volumetric Change

Loss

Gain

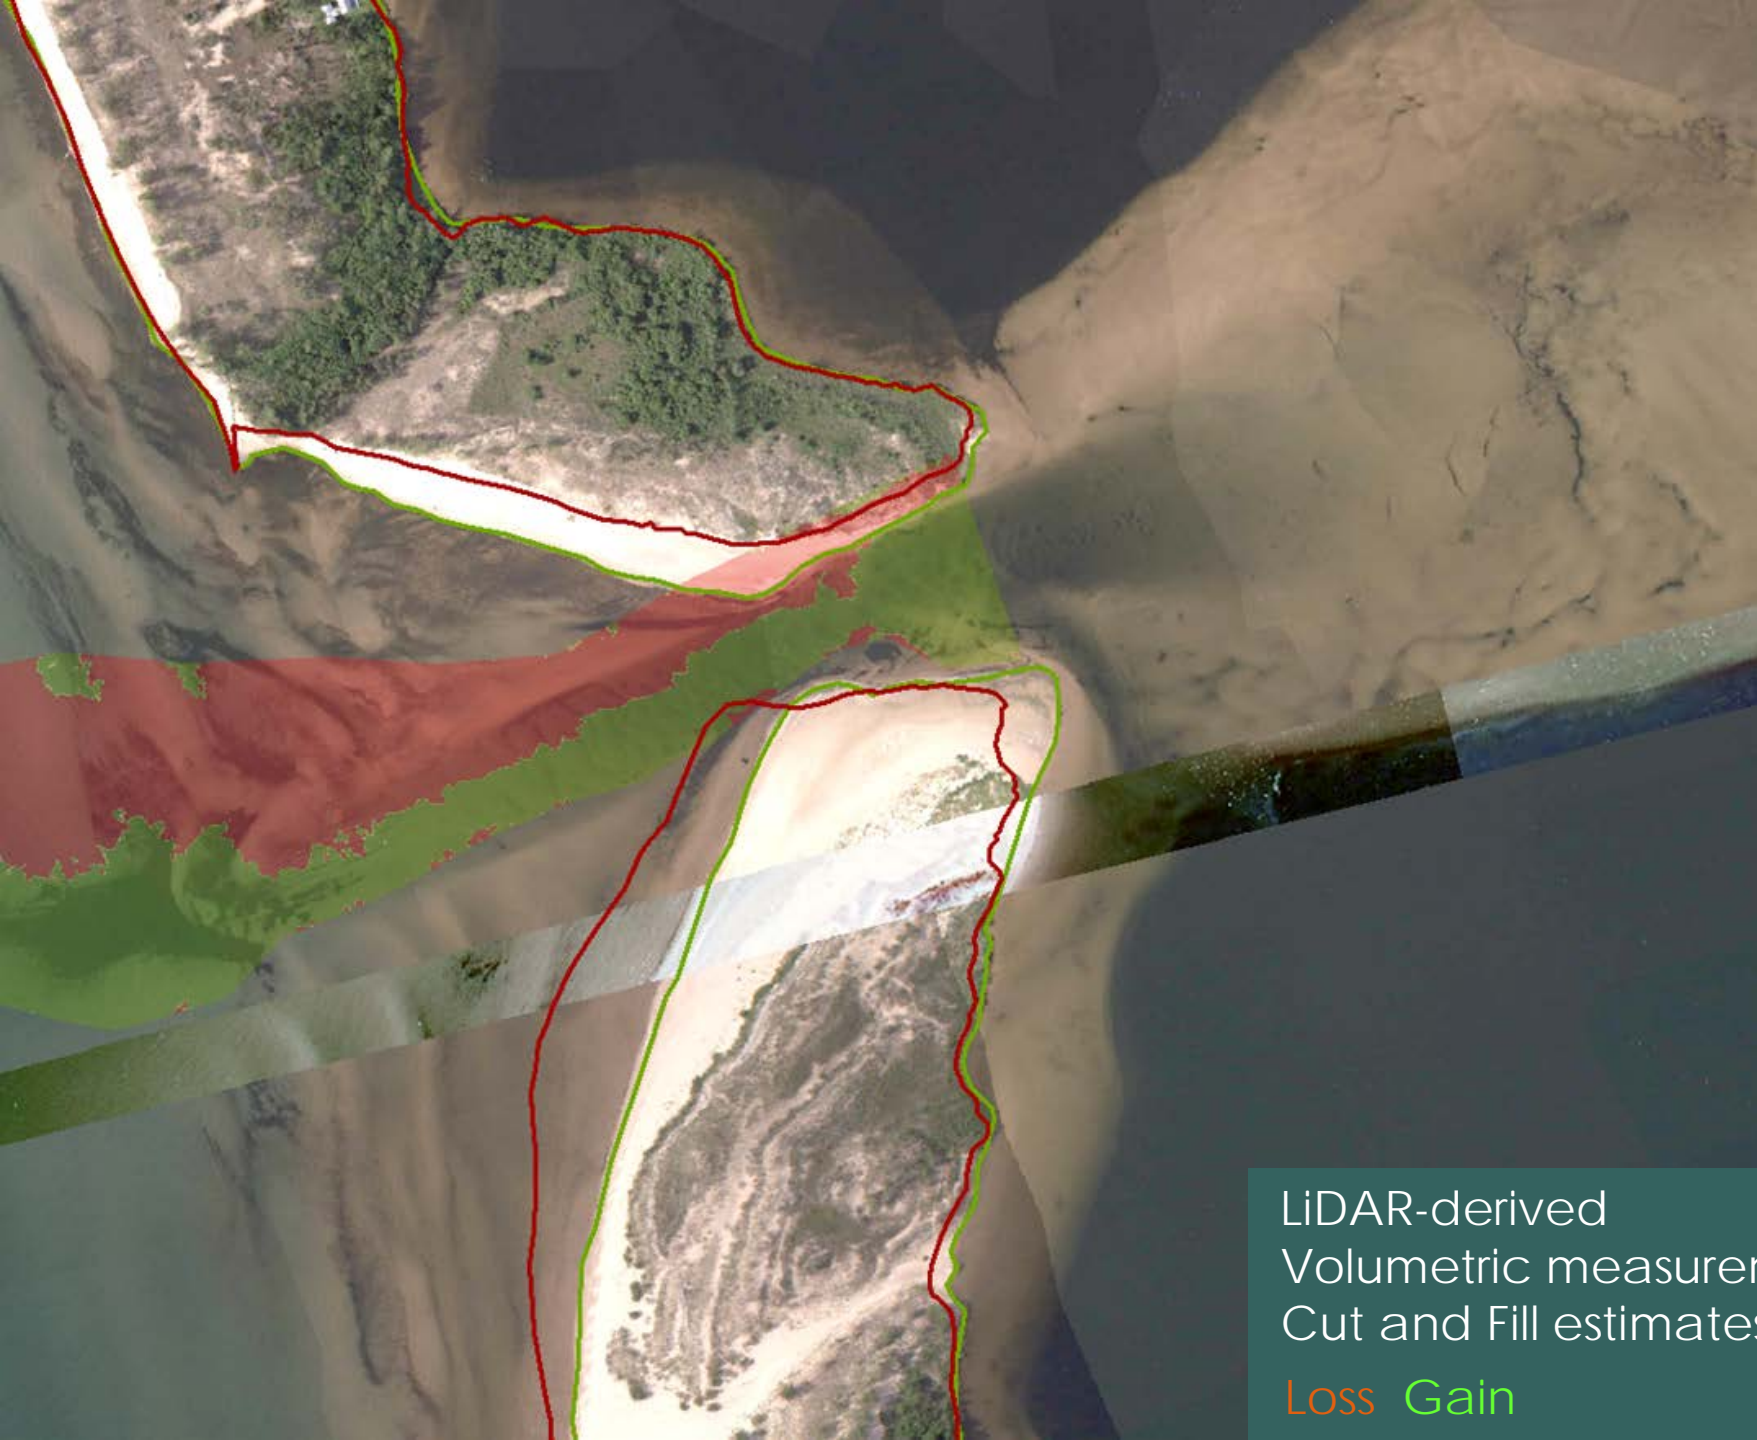
LiDAR-derived  
Volumetric measurements  
Cut and Fill estimates

Loss Gain

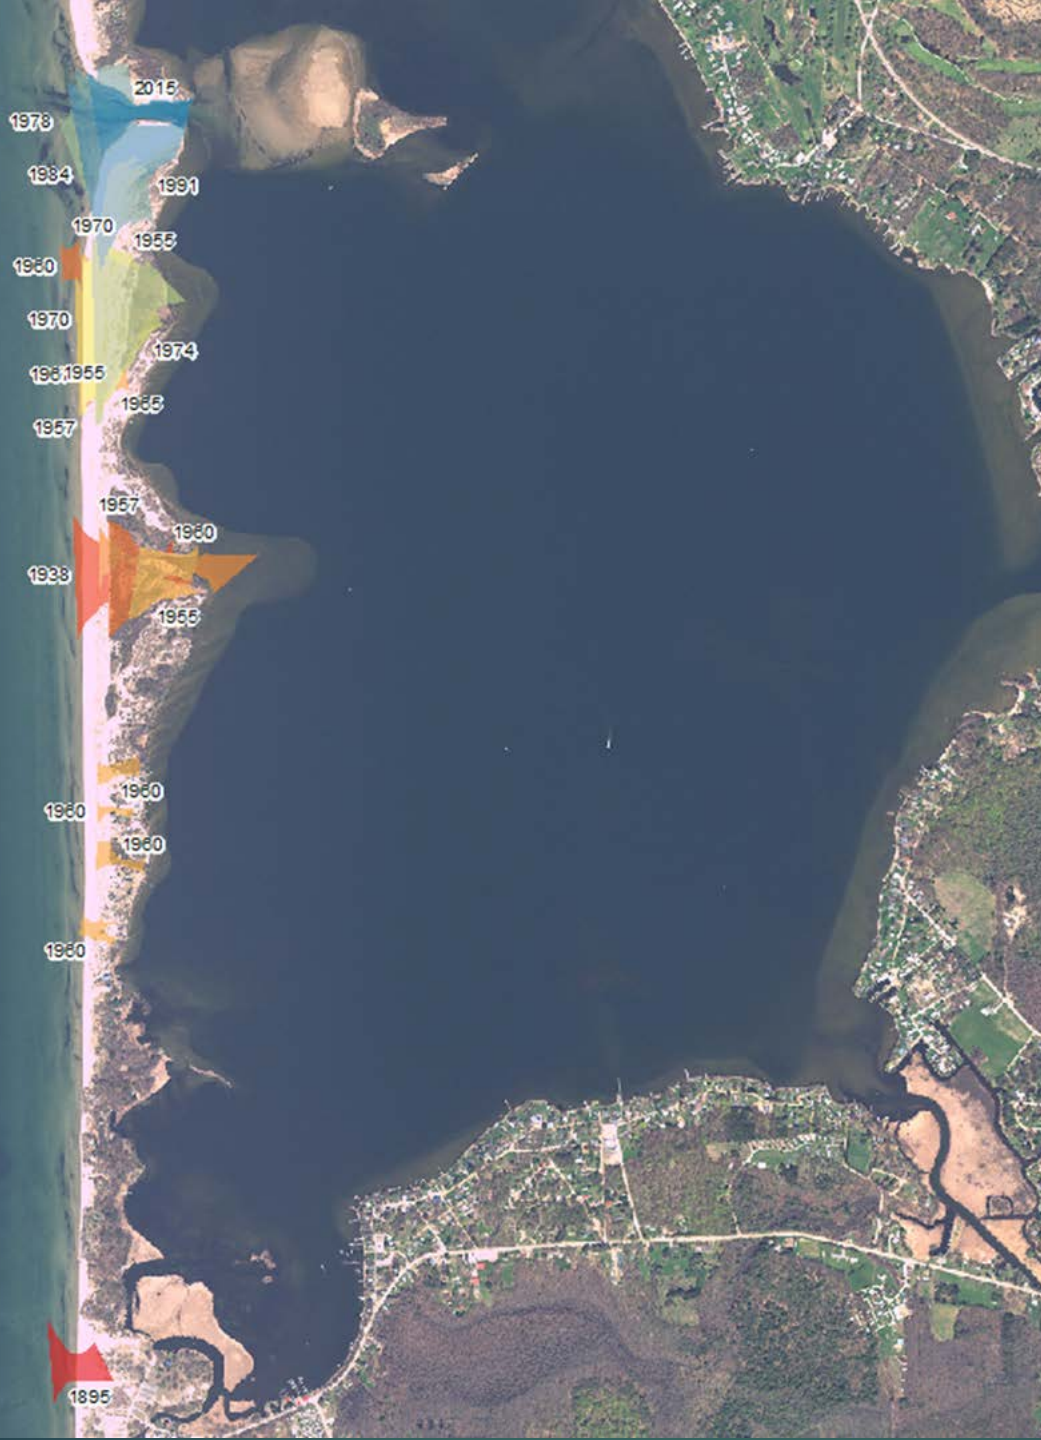
Inlet formation:

Major inlets

23 separate inlets  
and overwashes

**Looking down from the Sky on Outlet of Sandy Pond.**  
(Skyview by Dwight Church)

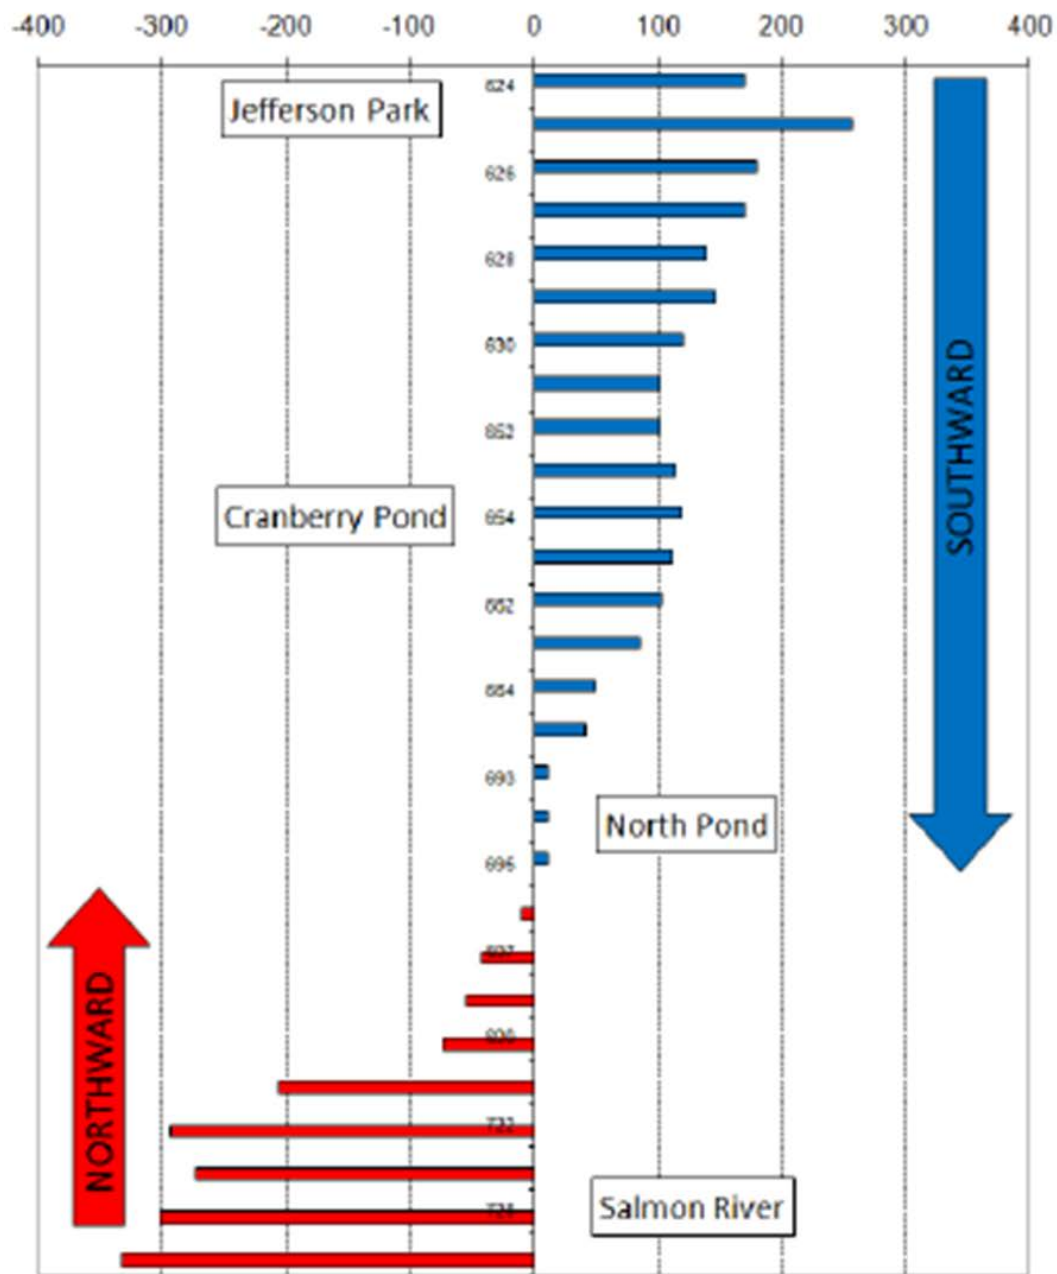
**ELO - Annual Potential LST**  
(in thousands of m<sup>3</sup>)
